The Evolution of Water Control in modern farming systems:

A Case Study of D & S Turner, Brookton, WA

Compiled by: Garren Knell & Trent Butcher

ConsultAg Narrogin 2019.

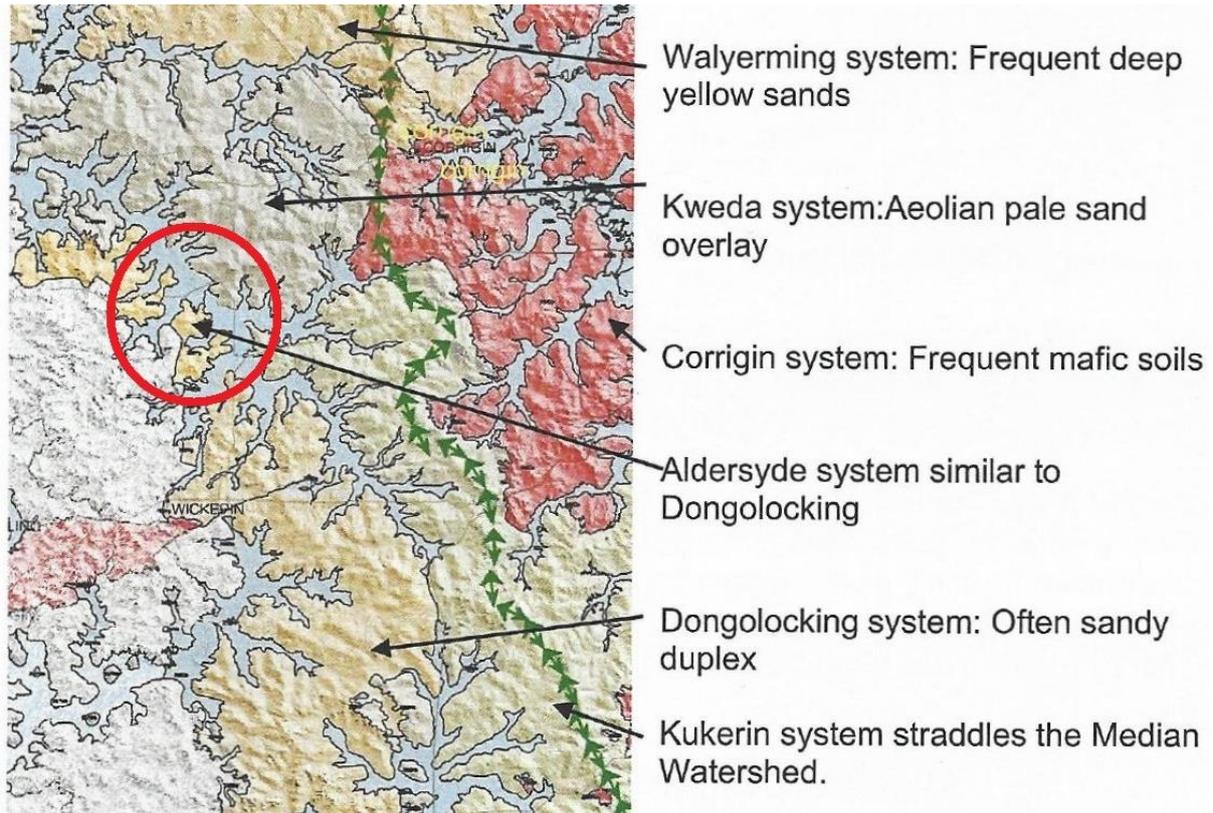
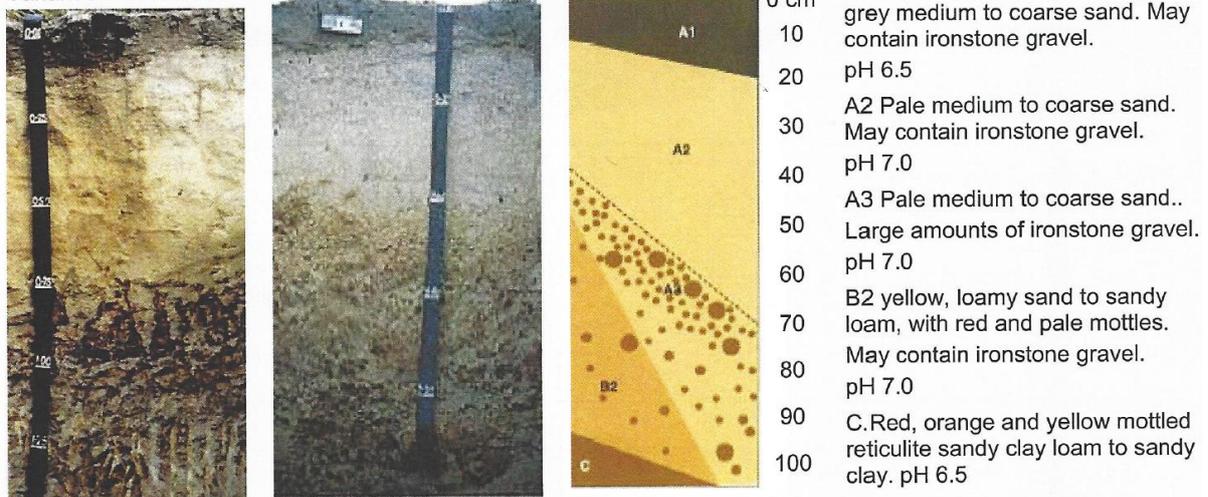
Figure 3: Different soil and landscapes of the southern Avon River catchment (Source: DPIRD)

The soils on the farm are typical of the area. The farm predominantly consists of sandy surfaced duplex soils with varying depth to clay or gravel. There are also clay river flats and shallow duplex soils associated with the valley floor and the Avon river flood plain. The soils in the district are characterised by the Department of Primary Industries and Regional Development (DPIRD) as being in the Ancient drainage system with the sandplain soils described as aeolian sandplain of the Kweda district (Kweda 259Ke – Bulletin 4807). See below figure 3 which identifies the different soils of the region, map courtesy of DPIRD.

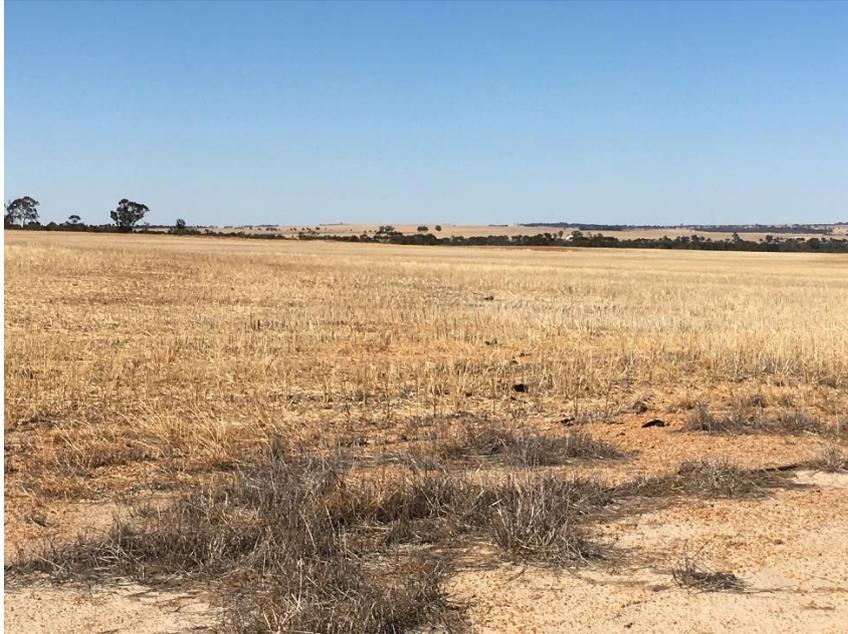
Figure 4: Image showing where a plastic lined dozer bank has been filled in. Plastic can be seen on the surface.

Figure 4 shows where W.I.S.A.L.T.S. banks were filled in leaving the plastic barriers in place. This has allowed the machinery to work over the barriers and removed the weed infestation from the banks.

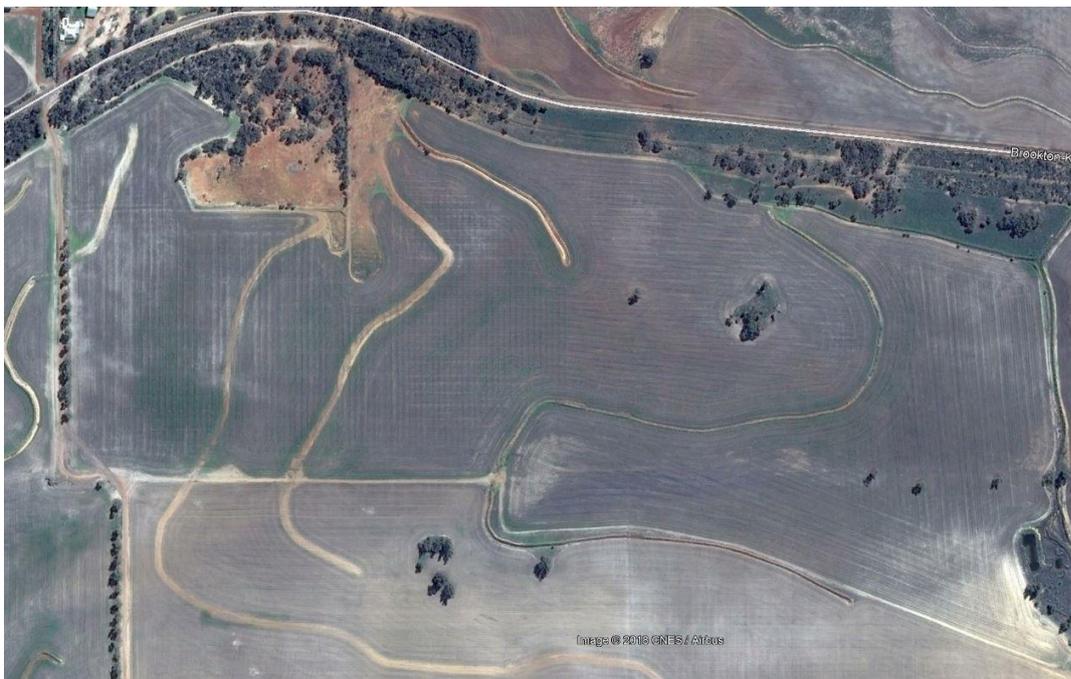
Figure 5: Aerial image showing where the two main banks have been filled in (but remain visible from air) and machinery now operated over the Interceptor barriers.

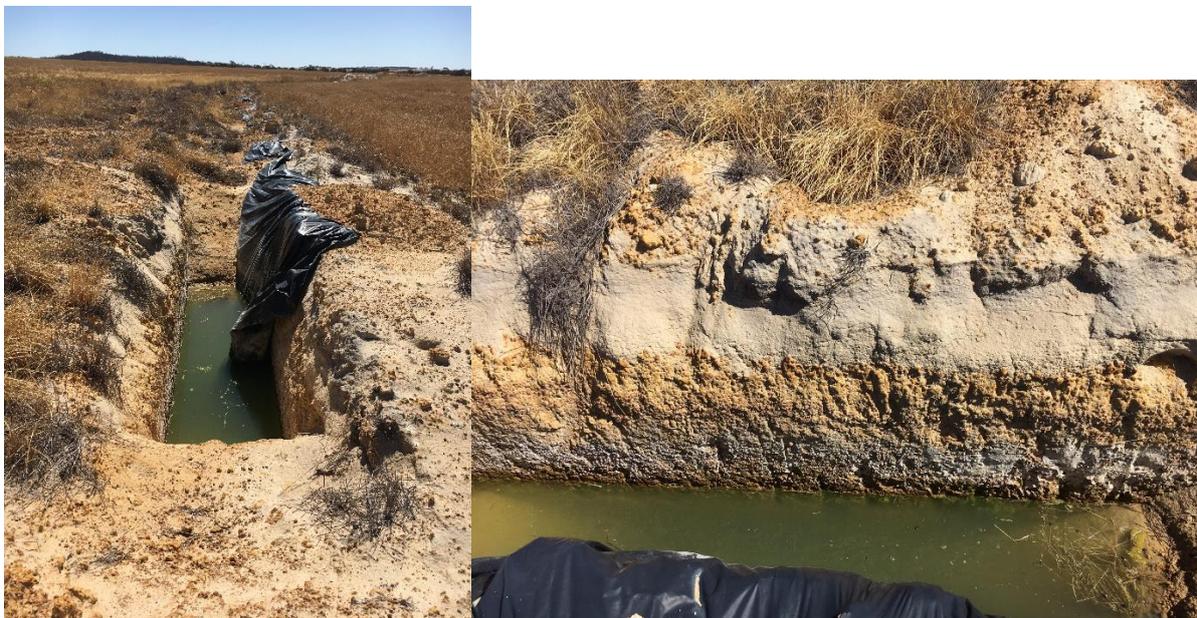
Figure 6: This image shows barriers being installed, water can be seen perched above the C horizon (approx. 1.6m) has seeped into the trench.

Usually the trenches to the hard, impermeable C horizon are less than 2m deep. This works well with 2m roles of plastic sheeting. The liner is to be fitted to the downhill side of the trench and the bottom of the plastic is to have a 300-400mm return on the bottom of the plastic (effectively forming an L shape) facing up the slope, this helps to seal the barrier and minimise water leaking between the plastic and the clay layer.

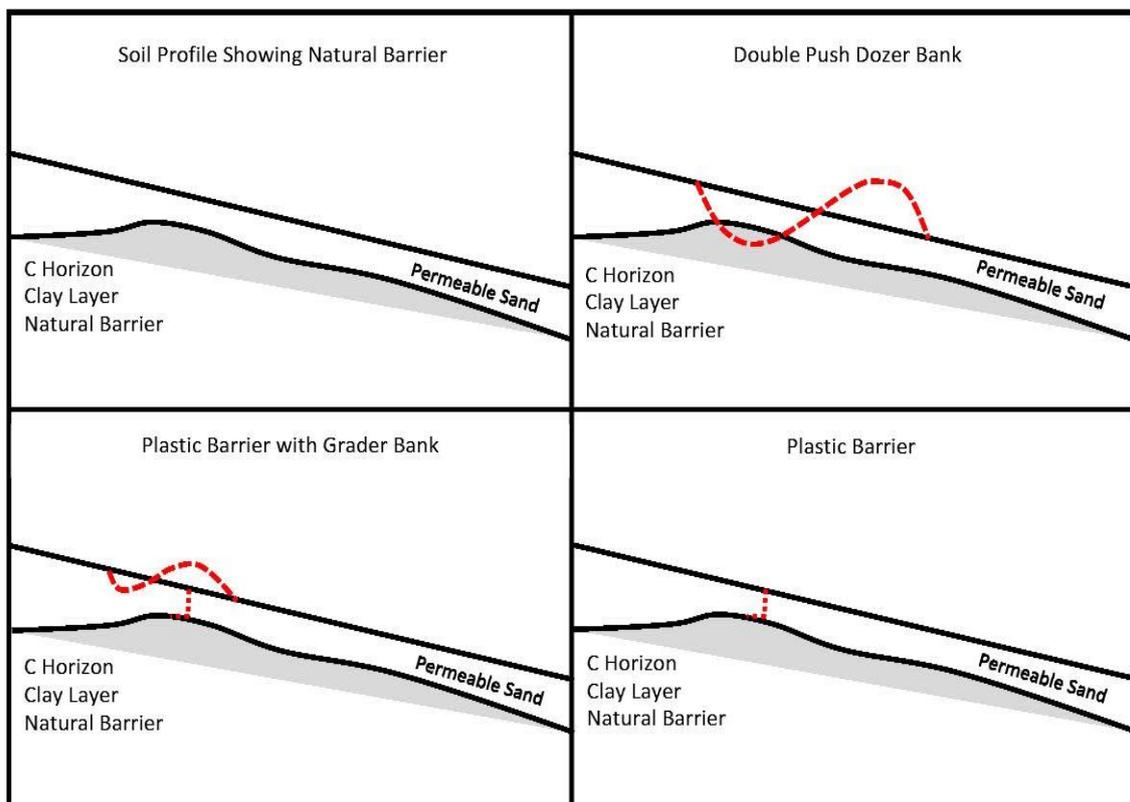
Figure 7: Schematic diagram showing site selection, the traditional W.I.S.A.L.T.S. banks, the grader bank + barrier and the Plastic Barrier

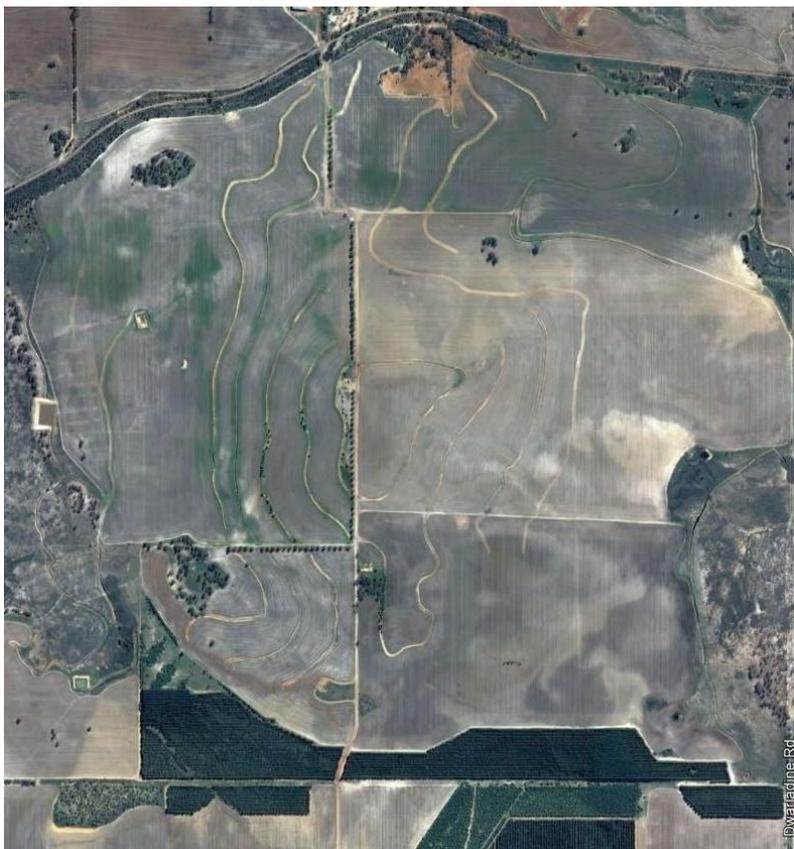
Figure 8: Showing image of Interceptor Banks installed on Darrell's farm during the 90's. Some of these banks are now filled in and replaced with Interceptor Barriers allowing easy working of paddocks.

Figure 8 shows how the interceptors are installed on the contour and can hold perched water in the landscape like rice paddies. Most of these were originally interceptor banks and Darrell is progressively filling in the banks and replacing them with Interceptor Barriers. This removes the above ground obstruction and allows easy working of the paddock and also prevents weed problems on the banks.

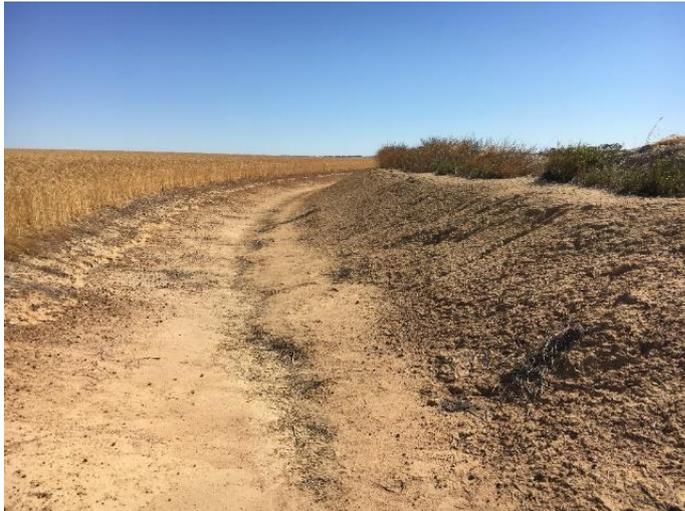
Figure 9: Image of dozer banks with burden of wild radish that can continually contaminate the paddock.

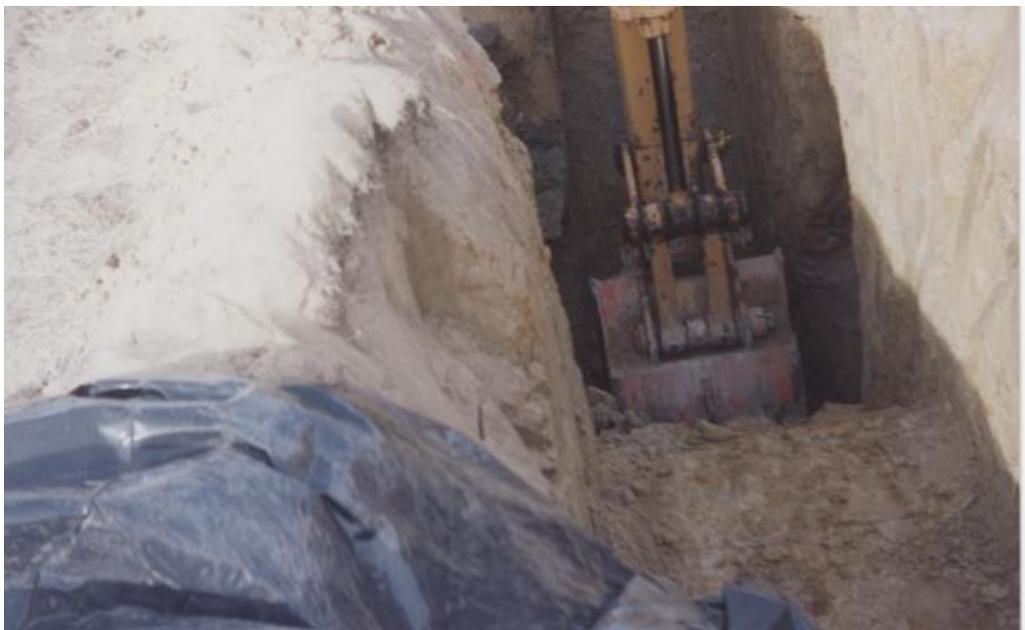
Figure 10: Showing trench being prepared to insert the plastic liner.

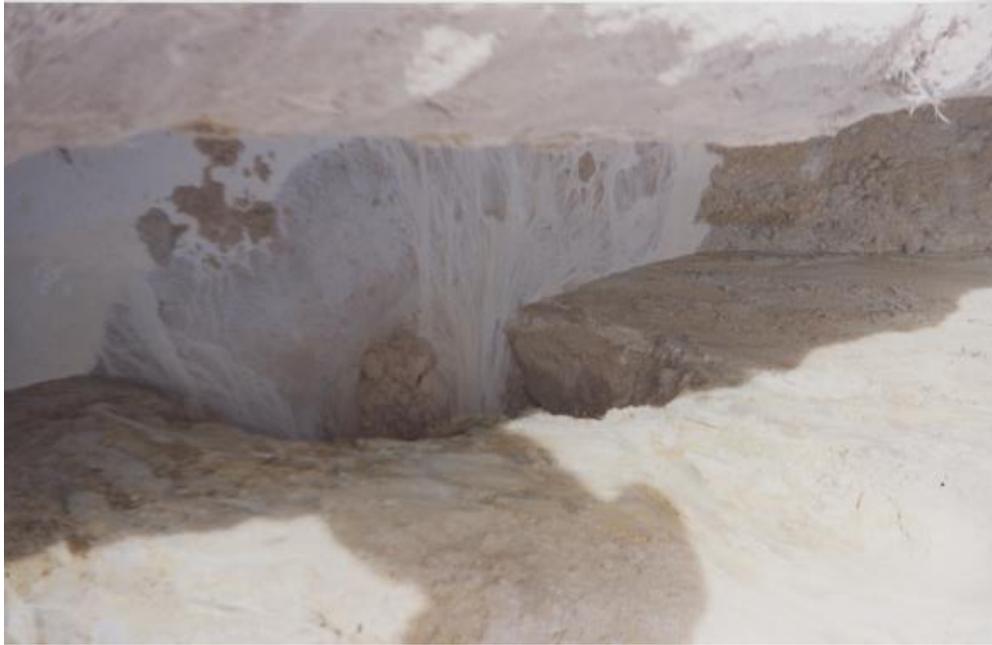
Figure 11: showing water gushing from the side wall of the trench prior to plastic insertion.

In 1998 Darrell decided to stop the below ground water from entering his paddock. As he felt that his farming system (continual cropping) could deal with the water that landed on the paddock but could not remove the water coming from upslope. An excavator trench was dug on the southern boundary of the paddock down to the clay layer (average 2.5m but maximum depth 4m) and a plastic liner was laid to impede water flow. This trench intercepted many below ground water channels that gushed fresh water.

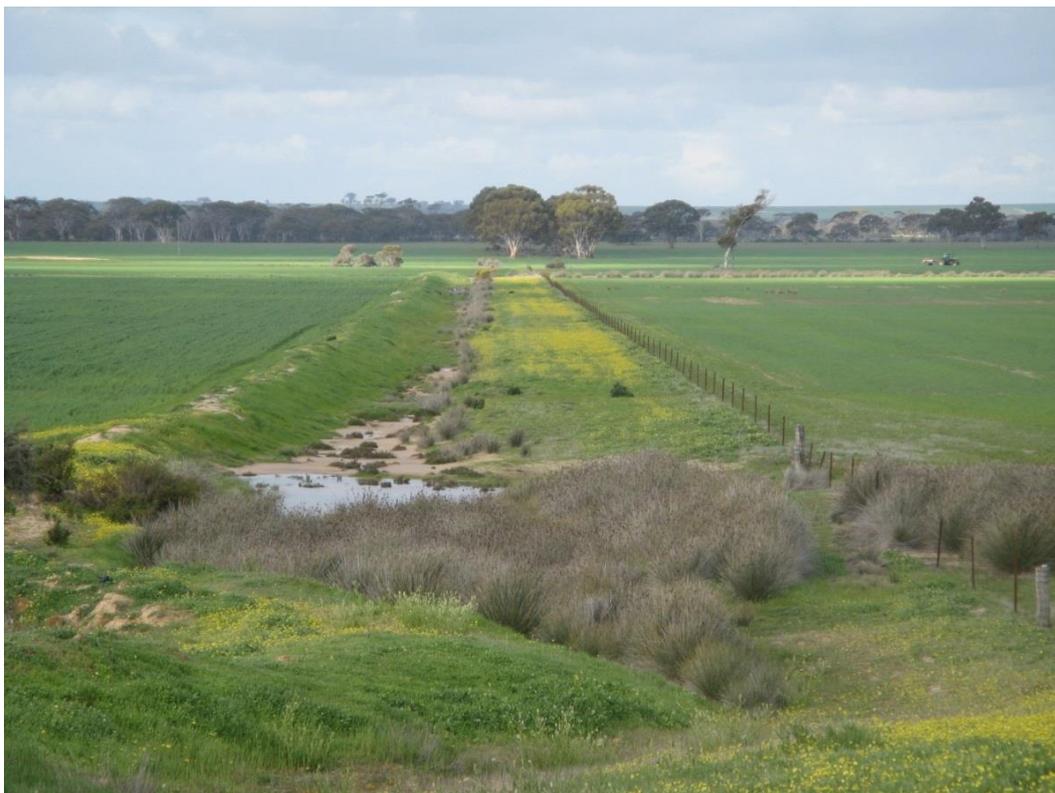
Figure 12: This 2002 photo shows the barrier in the centre dividing Mears (left) to the neighbouring (right). Since the photo was taken salinity has continued to spread on the right.

The productive area of the paddock has increased to 80Ha from 65Ha prior to the works. Waterlogging now only occurs in the wettest years. While there is still salinity in the drainage channels, this has not spread and has receded since the barrier was installed. It is obvious to see the extent of salinity spread in the neighbouring paddocks. Especially when comparing the areas north and south of the trench (Figures 12 and 13).

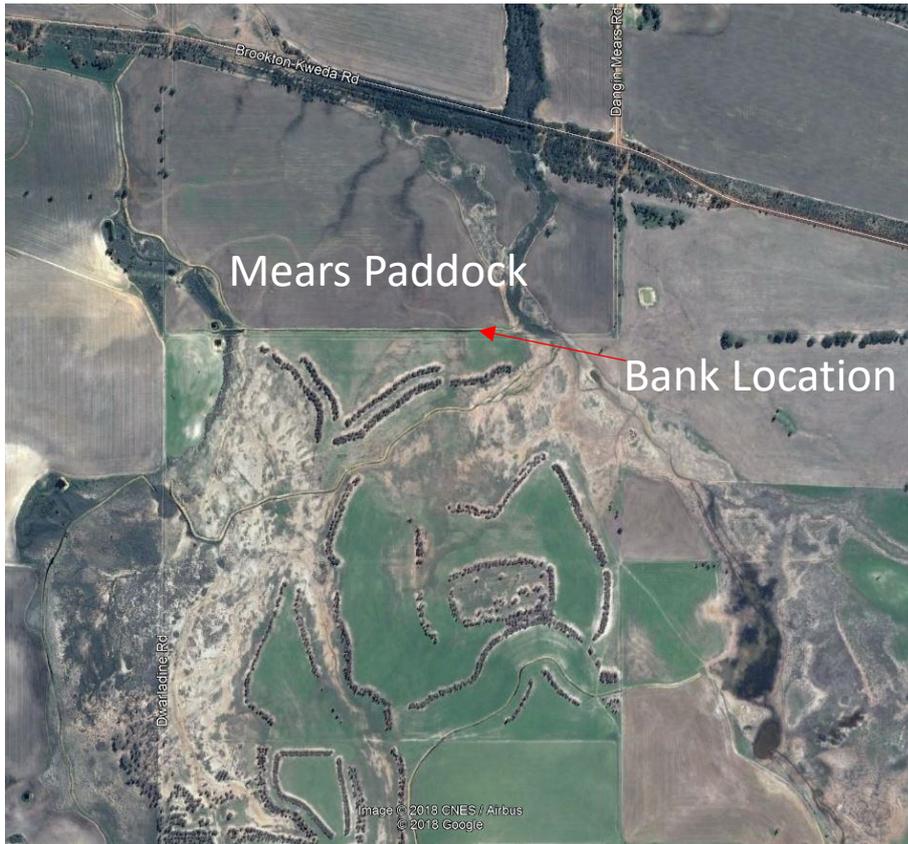
Figure 13: An Aerial photograph of the location of the bank in Mears paddock and the benefits it has had in halting the spread of salinity from the neighbouring paddock (2016 google earth image)

Case Study 1: Mears Paddock This is a flat low-lying paddock that was been inundated from water from the neighbouring paddock to the south (see google earth image figure 13). The natural drainage lines were beginning to go salty and the paddock was regularly waterlogged in winter. It was under threat of becoming un-arable from salinity and waterlogging.

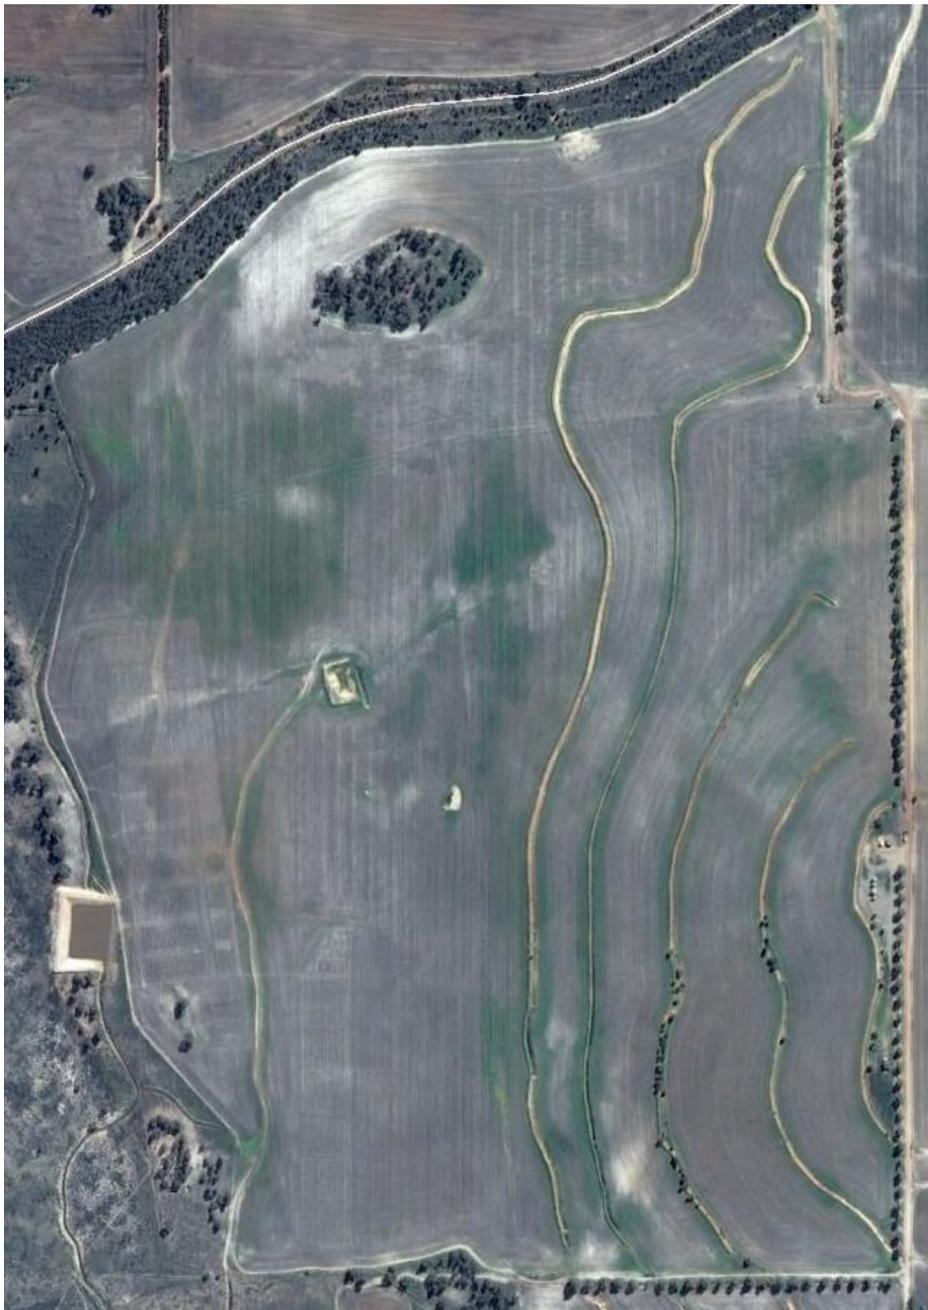
Figure 14: Aerial photograph of the location of the banks in the 3 in 1 paddock.

The Banks in the 3 in 1 paddock were installed during the transition period where the method of plastic lining was beginning to be implemented. All the banks in this paddock are the double push dozer type with the exception of some installation of plastic barriers where the depth of the sand was greater.

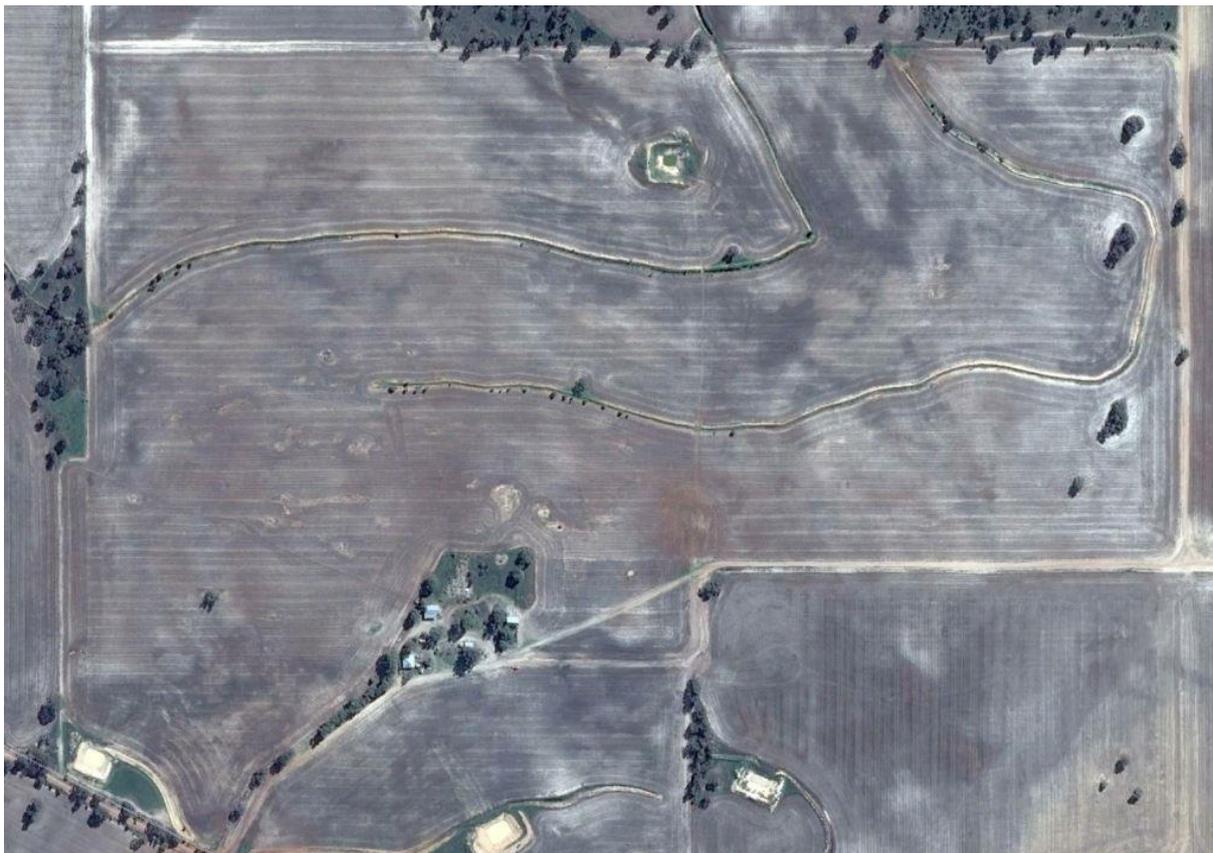
Figure 15: The distribution of the plastic lined banks in the landscape: Darrel plans to smooth out the banks in the paddock and maintain the plastic beneath the surface.

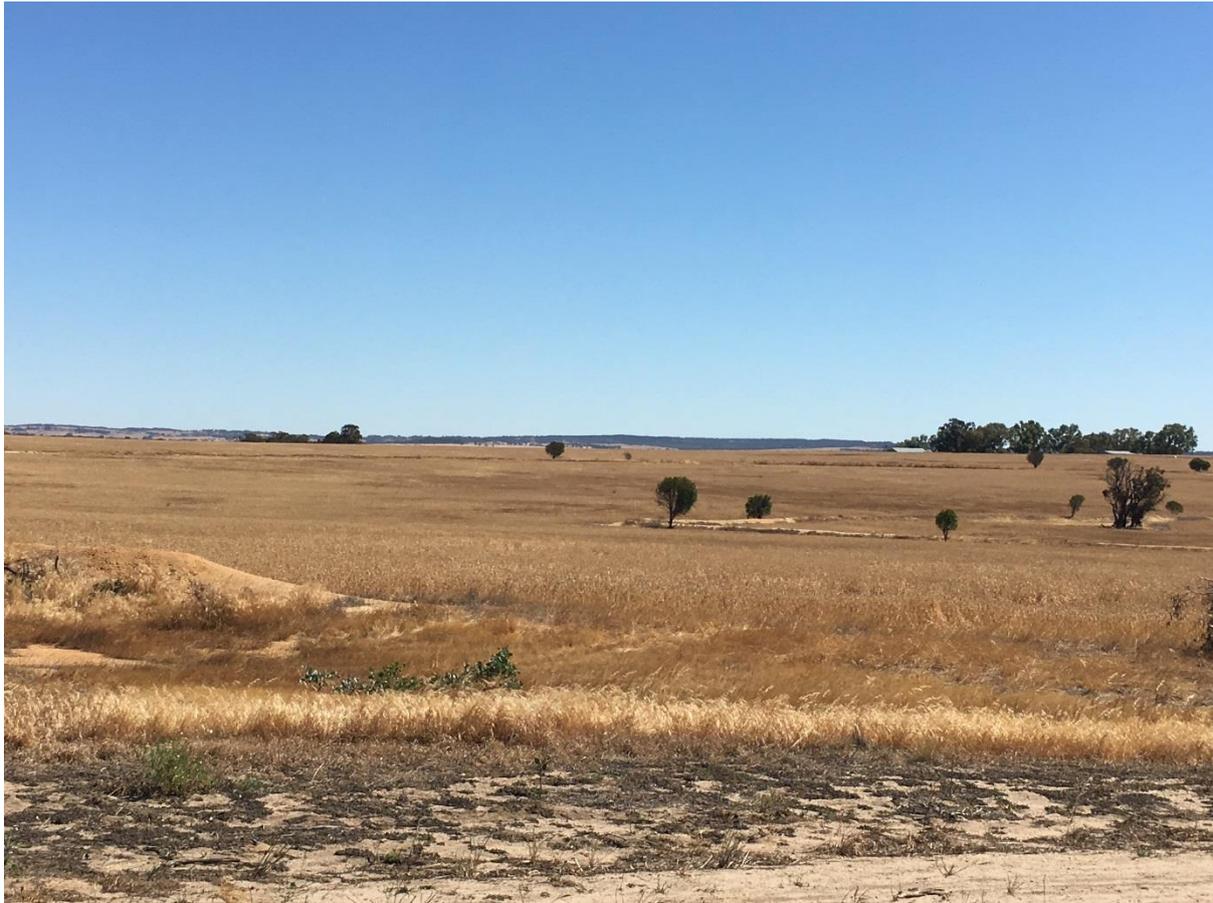
Figure 16: This image shows the placement of the banks on the landscape. Historically the steep elevation of the paddock led to significant overland flows. The introduction of no-tillage systems has made this problem obsolete

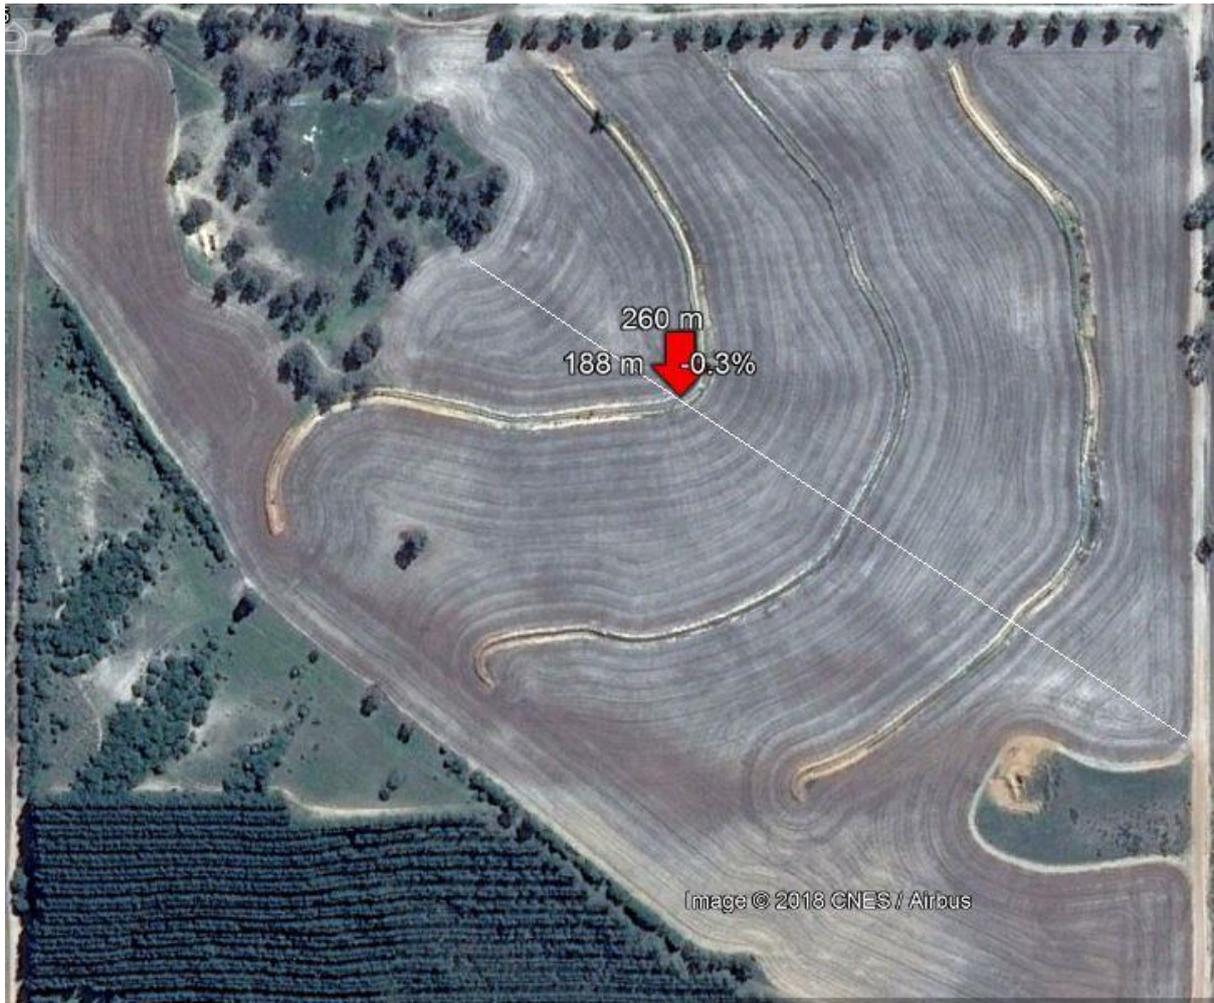
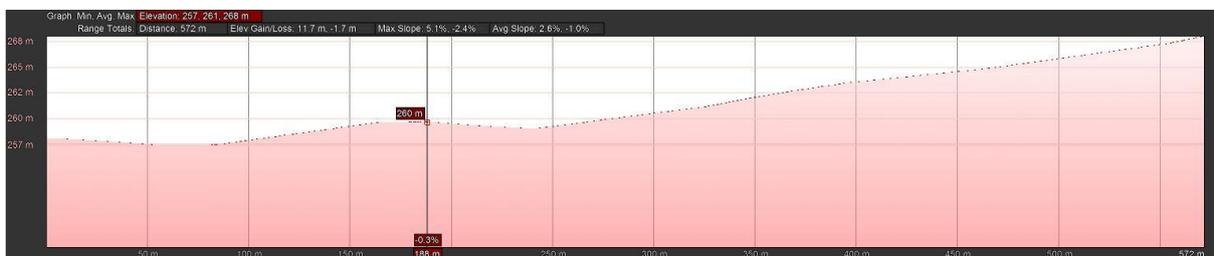
Figure 17: An aerial photo of the positions of the banks in the paddock and an elevation transect down the slope. The arrow marks the position of the banks relative to the elevation of the paddock depicted in the image below the aerial photo. The natural rise in the landscape has helped the bank to capture water. Note that Darrell has revegetated the unproductive deep white sands with Pinus Radiator plantations. These pine trees have grown well on this site and they prevent the recharged of ground water and will hopefully generate a return in the future.

The middle bank seed in figure 17 has a plastic barrier installed. This has now been filled in allowing easier working of the paddock with modern tillage and paddock management equipment.

The top and bottom banks are double push dozer banks (without plastic). These are no longer needed to manage surface water and they leak under waterlogging conditions. They will be filled in in the near future. Darrell believes the plastic barrier is doing most of the work in managing waterlogging.

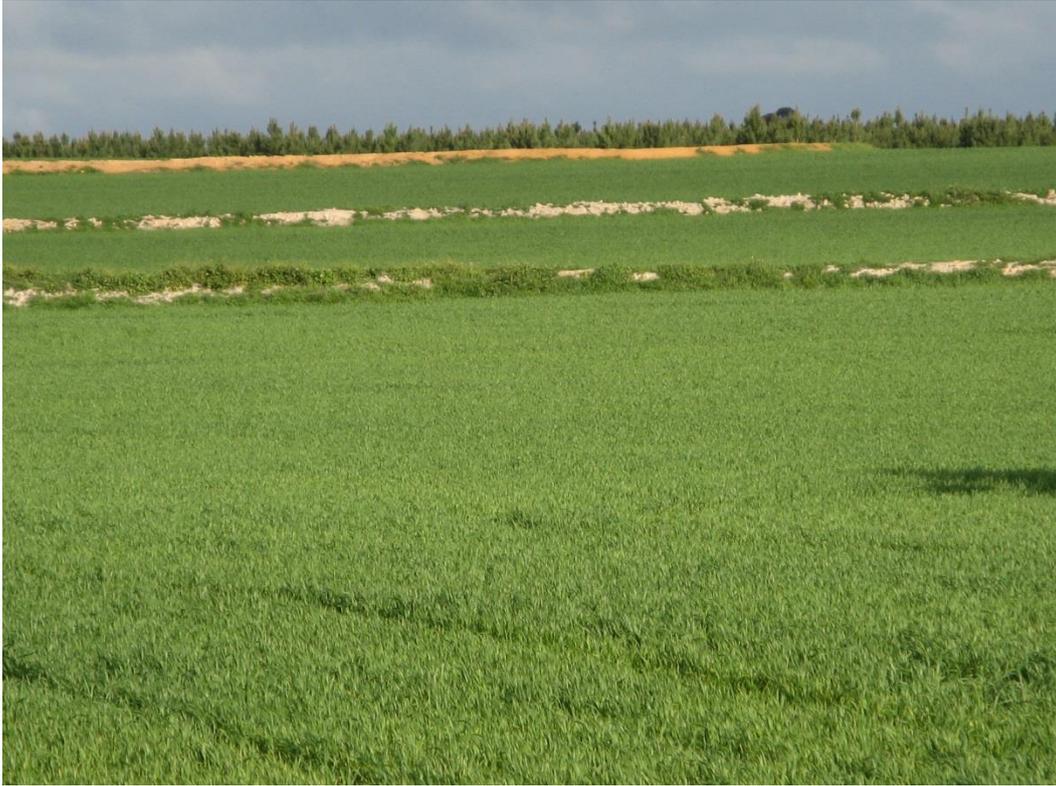
Figure 18: This photos shows the banks acting like “Chinese Rice Paddy” terracing to hold water in the landscape. Photo shows use of trees on deep white sand recharge area (low arability). The centre bank has now been filled in.
